Rubble-Mound Breakwater Wave-Attenuation and Stability Tests, Burns Waterway Harbor, Indiana

Technical Report CERC-93-15
August 1993

Final report

Prepared for U.S. Army Engineer District, Chicago
Chicago, IL 14207

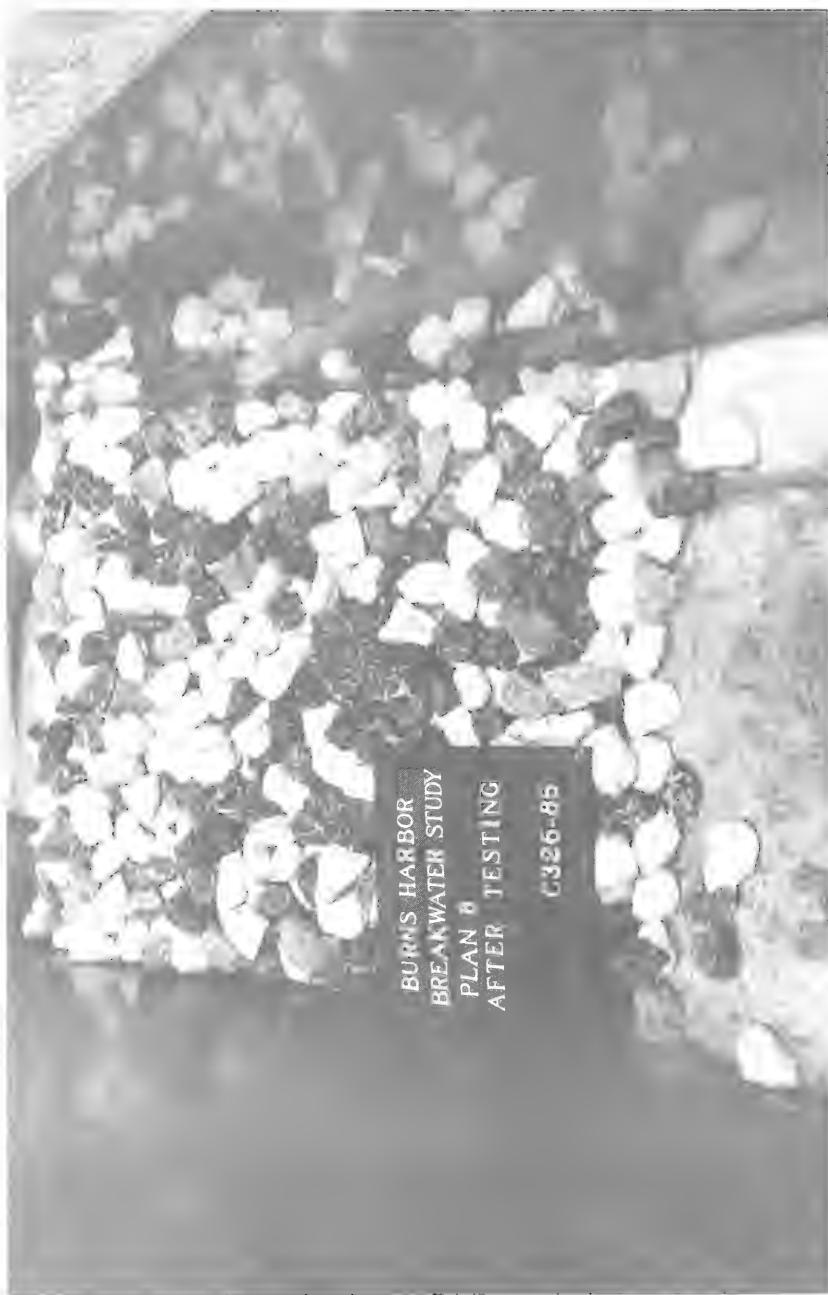
Photo 47. End view of Plan 8 after wave attack

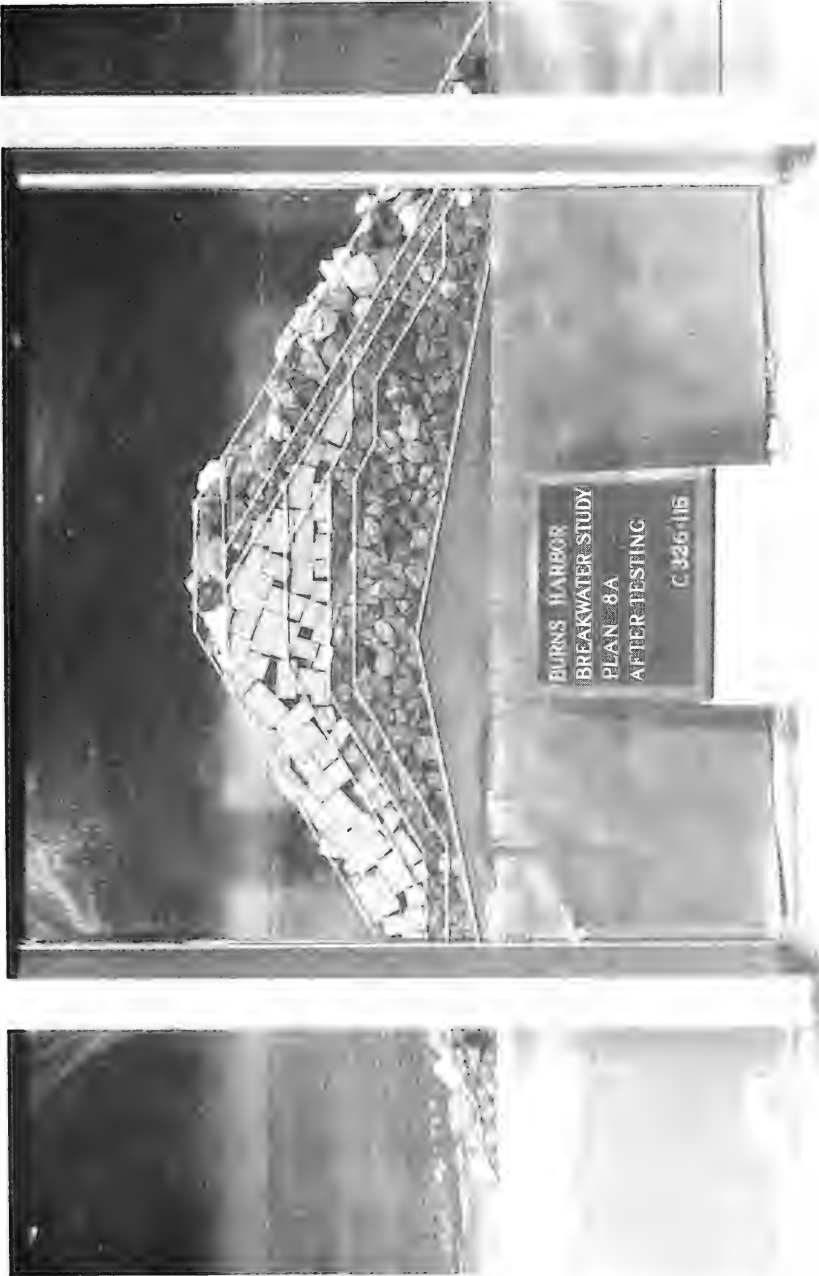
Plan 8A (Figure 24 and Photo 50) consisted of adding one layer of 18-ton stone to the crest and two layers of 10-ton stone to the harbor-side face of the structure. Also, a 4-ft-thick layer of 1,000-lb stone was placed beneath the 10-ton, harbor-side stone. Transmission results were as follows:

Photo 50. End view of Plan 8A before wave attack

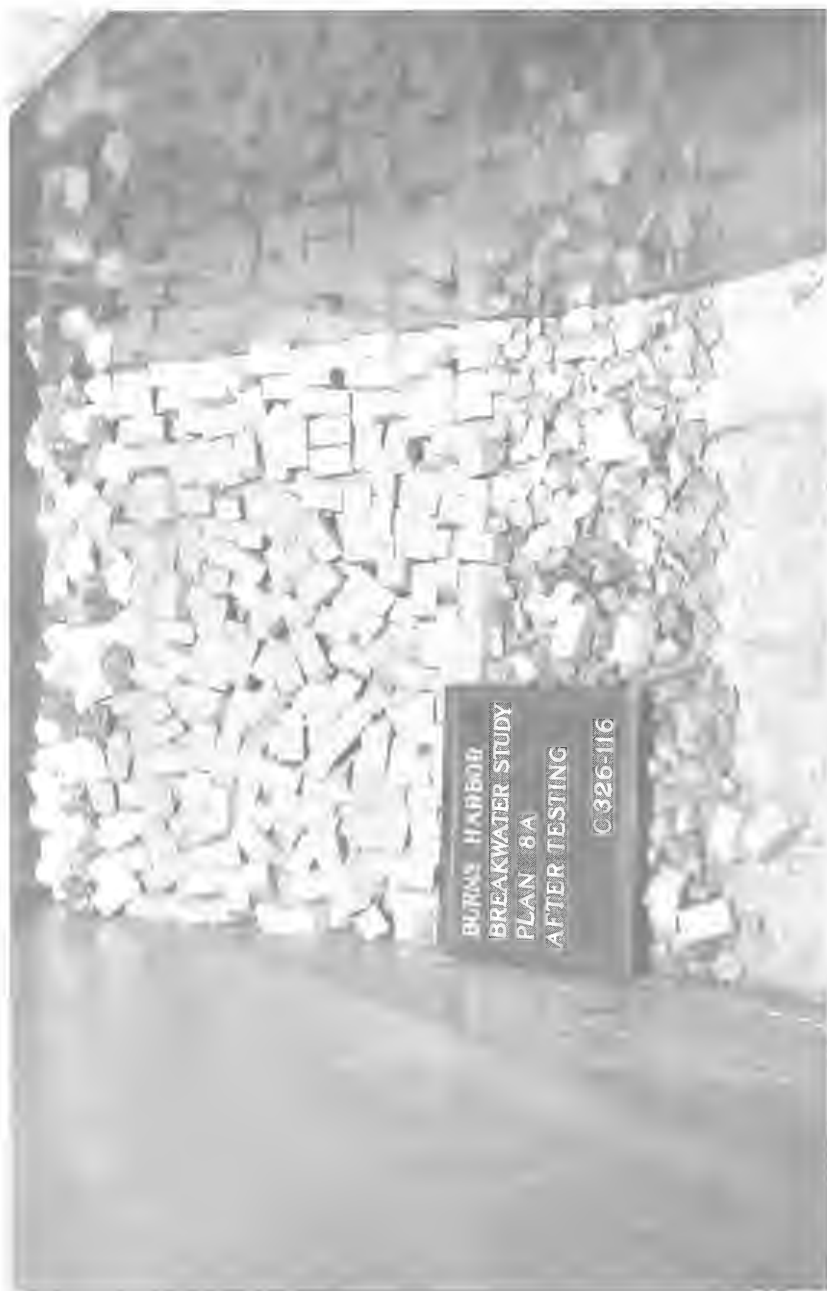
- e.* Plan 8A, the only harbor-side repair option tested, was one of the most successful plans in terms of reducing wave energy; however, stability was marginal.

Photo 51. End view of Plan 8A after wave attack

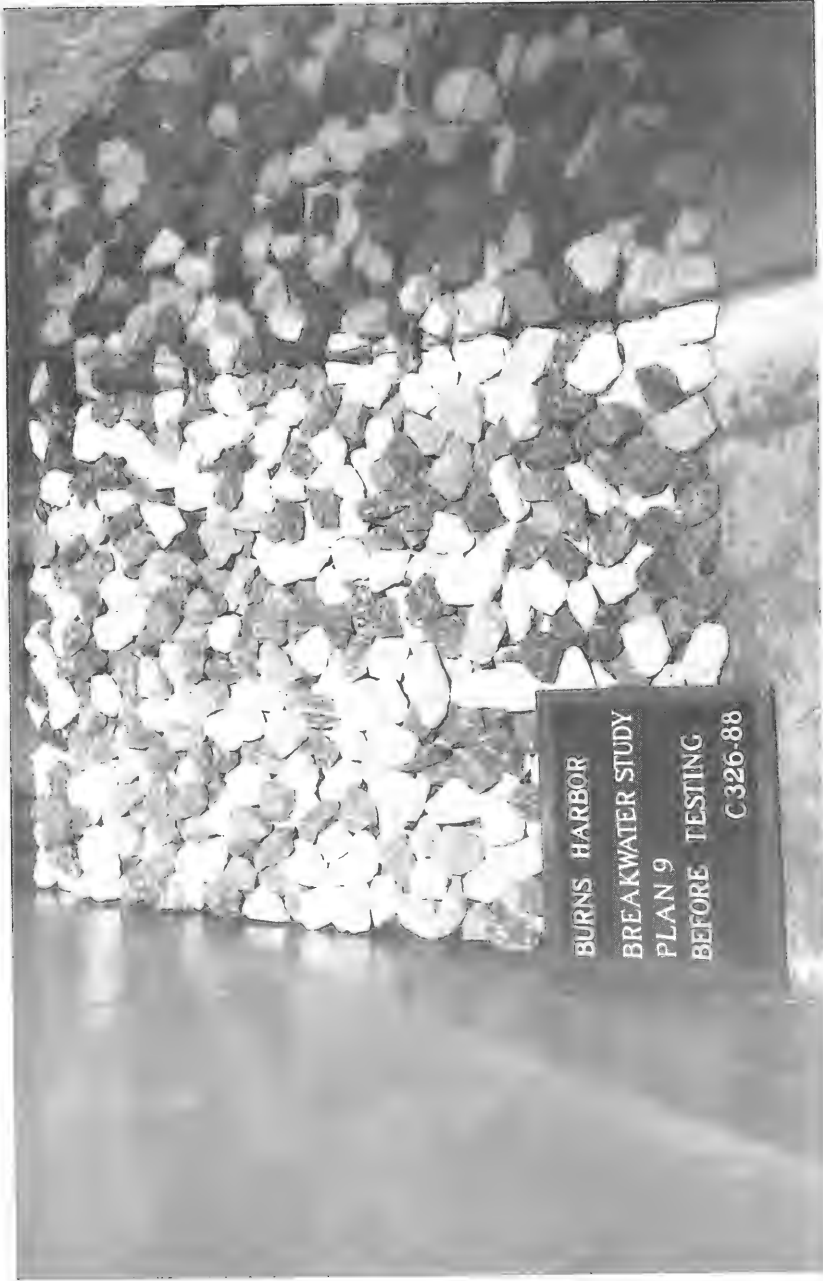
Plan 9 (Figure 26 and Photos 54 and 55) was the same as Plan 8 except the slope of the 18-ton overlay stone was flattened to 1:2.25 in an effort to improve lakeside stability. Transmission test results were as follows:

Photo 54. End view of Plan 9 before wave attack

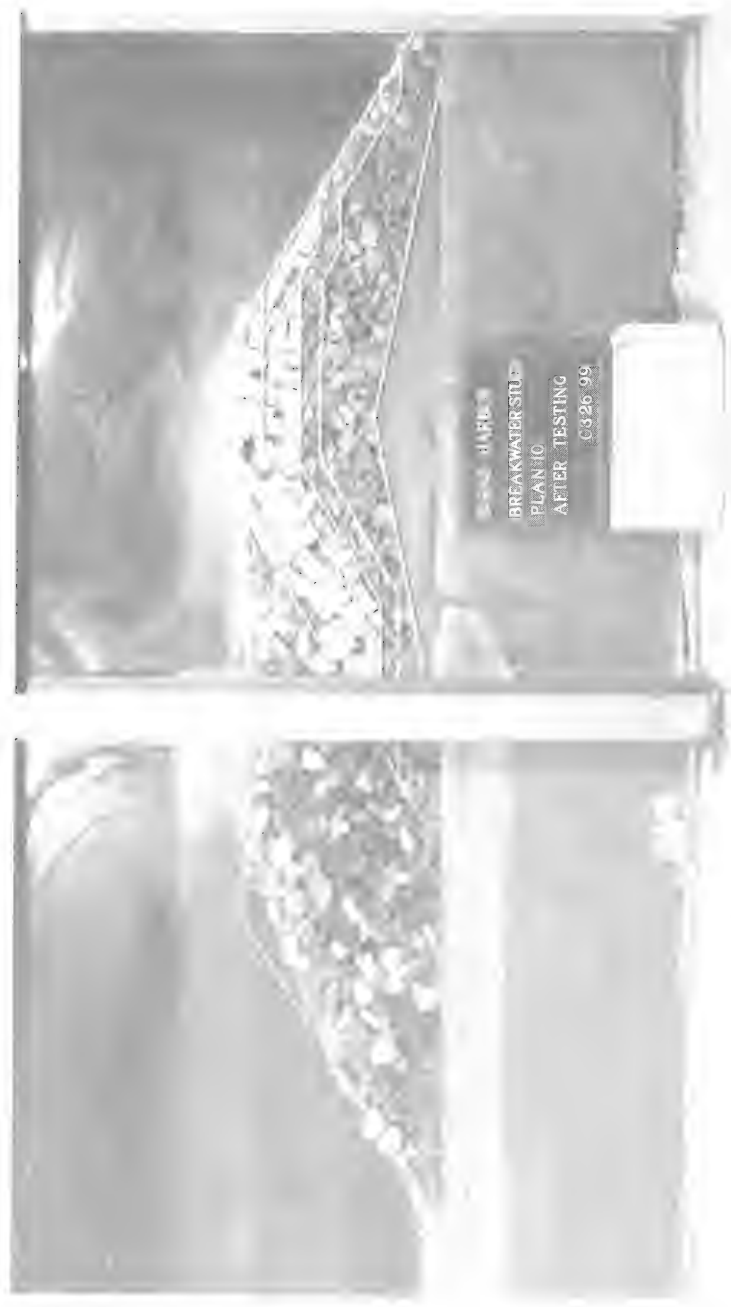
Plan 10 (Photo 59), tested at both the 0- and +4-ft swl's, produced the following results:

Photo 59. End view of Plan 10 before wave attack

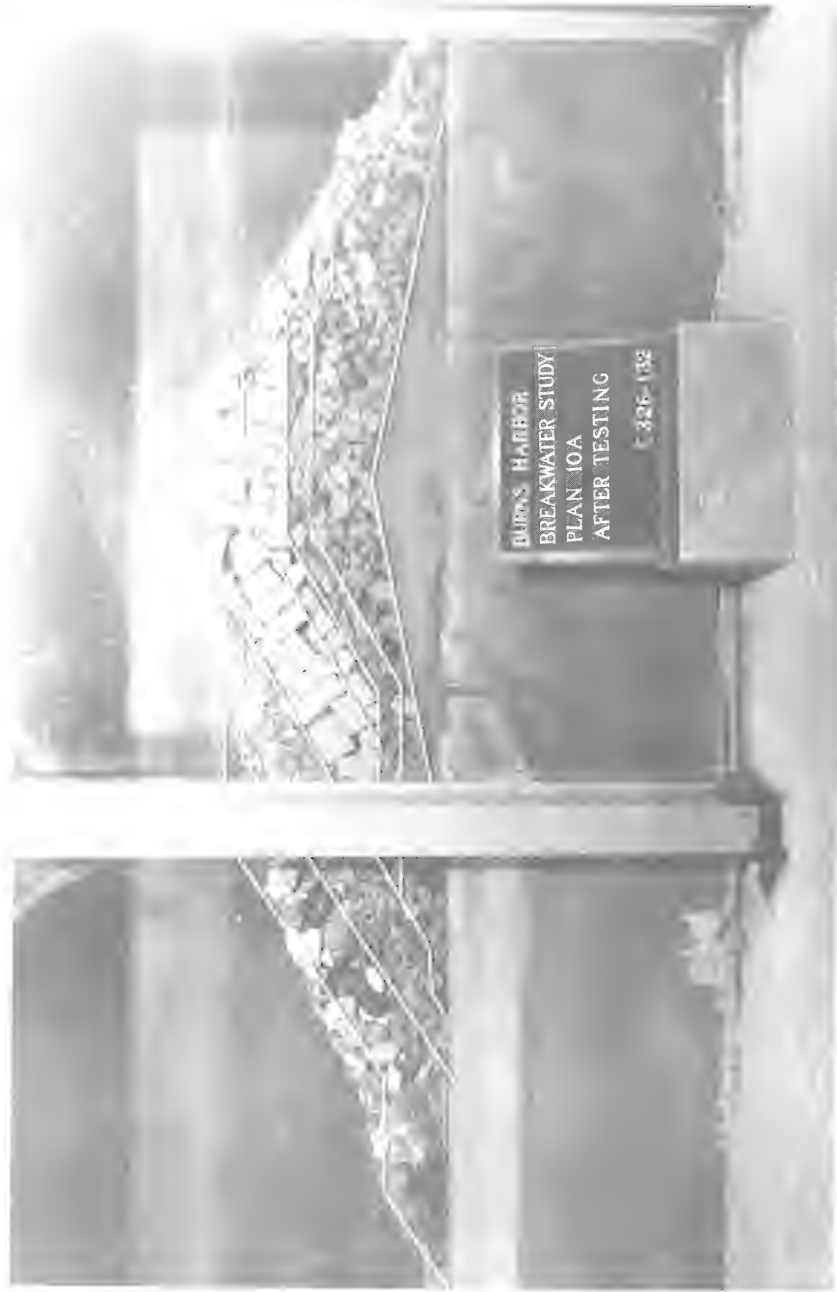
Plan 10A (Figure 36 and Photo 63) was similar to Plan 10, except the berm was reduced in width from 100 to 50 ft and the impervious plastic sheet was replaced with 1,000-lb filter stone. Testing at the +4-ft swl produced the following results:

Photo 63. End view of Plan 10A before wave attack

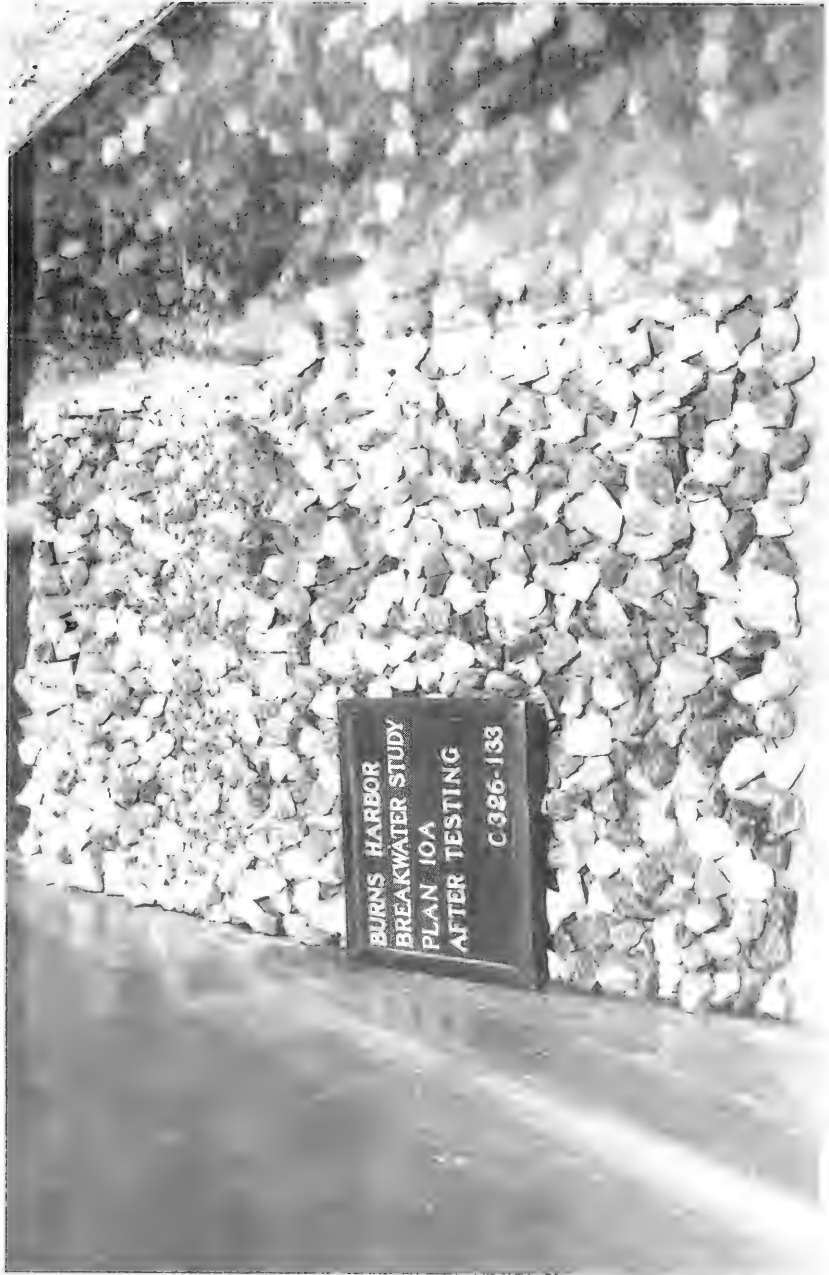
Photo 64. End view of Plan 10A after wave attack

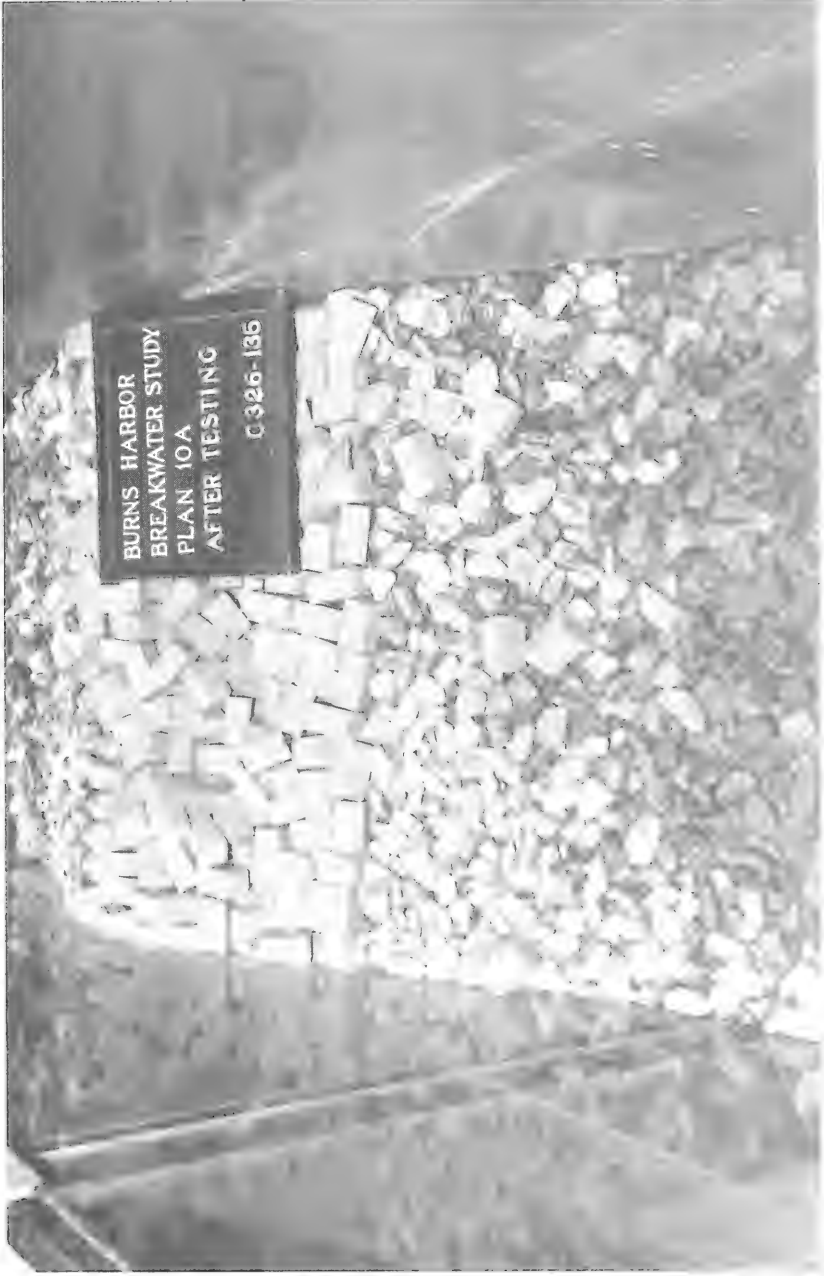
Photo 66. Close-up view of damage incurred by 5-ton stone in the vicinity of the swl
